Preservation of Vat Phou monuments: results and perspectives

*Pierre Pichard**

“La conservation des monuments de Vat Phu : bilan et perspectives”, BEFEO 97-98 (2010-2011), 2013, pp. 315-330.

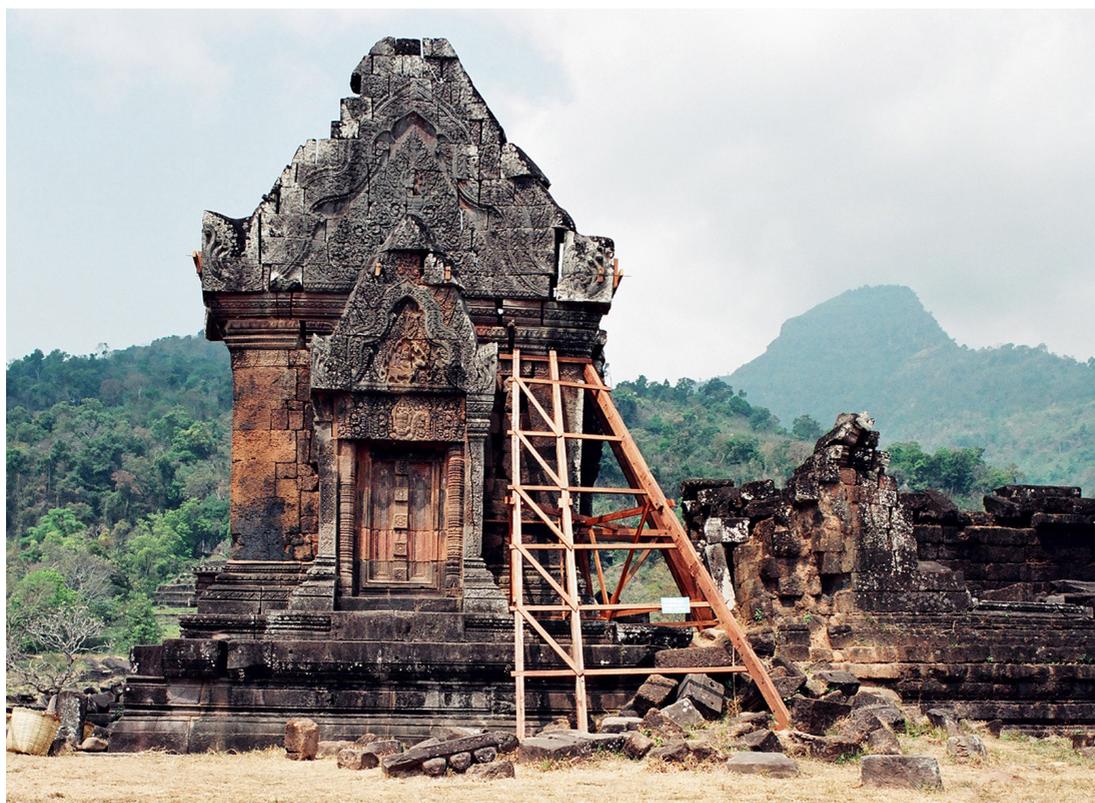
fig. 1: North quadrangle, 1997. Shoring up of a dangerously cracked angle in the main gallery

with no result, it was decided to proceed immediately with the shoring up of some especially unstable structures [fig. 1]: it was above all necessary to show by example that it was high time to proceed from theory to practice.

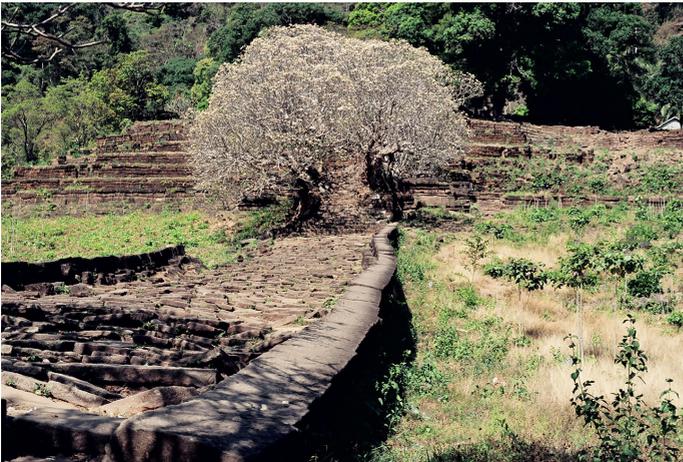
fig. 3: Access ramp to the fourth terrace and supporting bleachers of the upper terrace, 1997. The well preserved bleachers of the southern side, to the left, contrast with those of the northern side which have been damaged by running water following an ancient rock slide. Under the frangipanes, the present and practically inaccessible stairway covers the original steps with recuperated stone

These sectorial operations are only the first steps of the monument's global preservation. They should be followed by re-establishing aplomb lines and levels on terraces and stairs. The stairs which access the 4th terrace, for example, were covered with recuperated stones at an unknown date (fig. 3). Clearing these will uncover the original steps and moulded sides surmounted by a beautiful terrace and *nāga*-balustrade. The operation will restore its former nobility to this ascension to the upper temple, while making the climb easier for visitors.

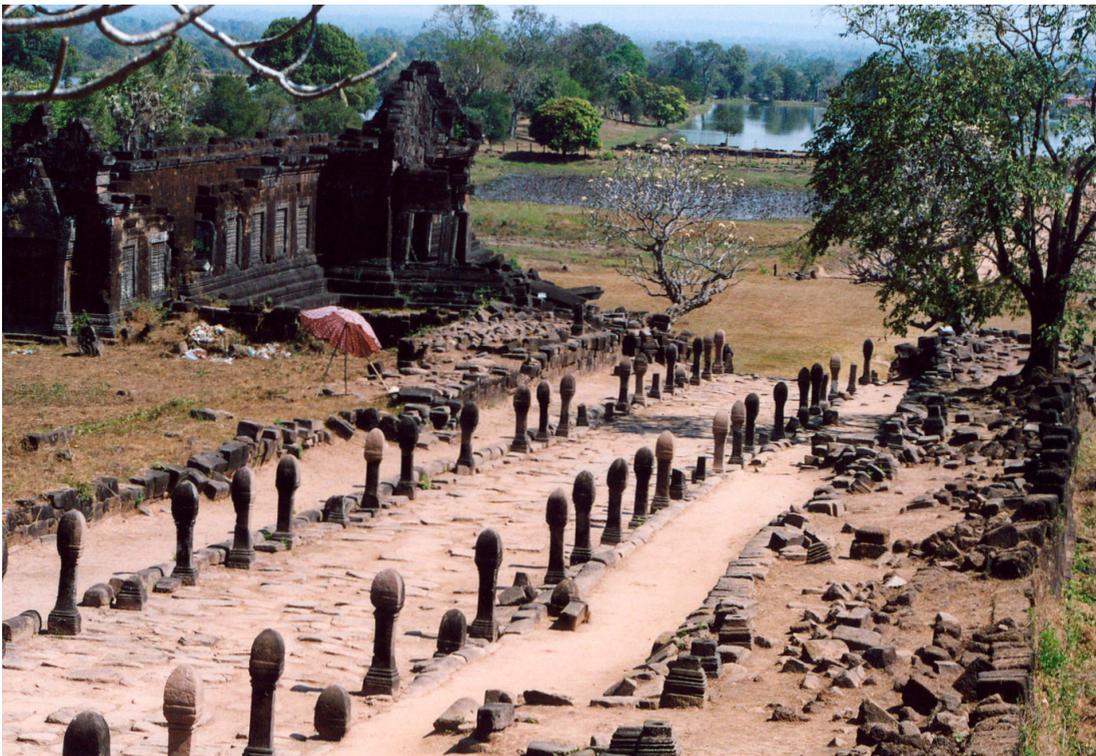
fig. 4: The ceremonial road, as seen from the southwest in 2006, with reassembled and straightened milestones

Preservation operations began in earnest in 2005. Under the direction of Patrizia Zolese, the flagstones of the access avenue were levelled and milestones were straightened on a length of 400 metres [fig. 4]. Since most of these had been broken, an Italian restorer, Paolo Pagnin set up a workshop to train a Lao team to assemble their fragments. During this campaign, scattered stones from an old eastern pediment landslide in the southern quadrangle were classified, identified and then reassembled on the ground. Although still small, these worksites trained the local staff to manipulate sandstone blocks, record documentation and use the available equipment: the following stages would be more ambitious.

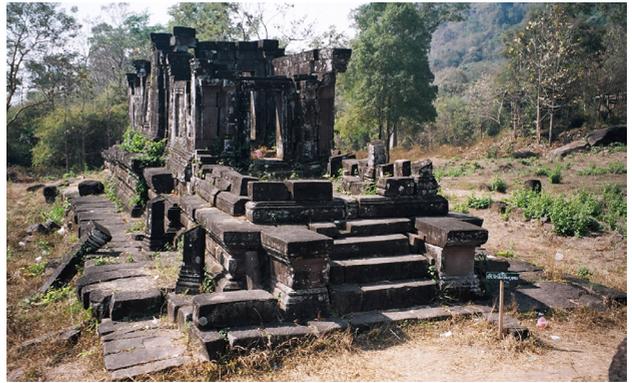
fig. 5: The southern building, known as Nandin Hall from the northeast, before work, 2006

In 2006 the Leric Foundation undertook the restoration of Nandin Hall, a small isolated building in the south of the site. This sandstone and laterite structure had come apart when its foundations weakened and the surrounding ground eroded [fig. 5]. Dismantling the walls and the foundation allowed them to reach the original level and stabilise the internal northern landfill [fig. 6]. Led by Mara Landoni and Phakhanxay Sikhaxay, the work is expected to continue on the other end of the building.

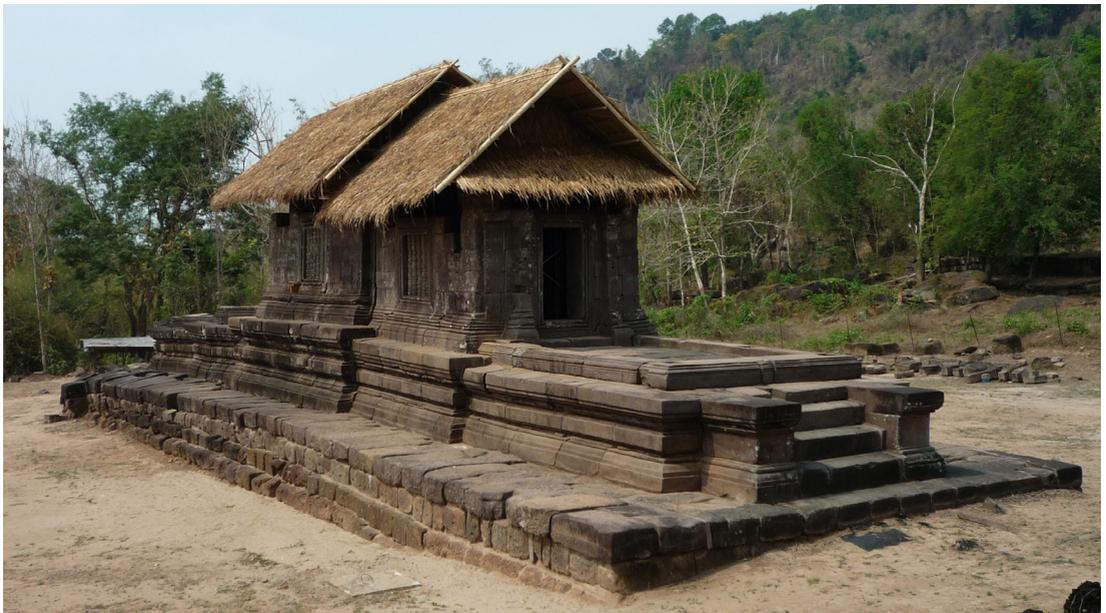
fig. 6: The southern building in 2010: in the foreground, the northern portion is rebuilt and stabilised. In anticipation of the rainy season, a temporary roof protects the central area where drains have not yet been installed

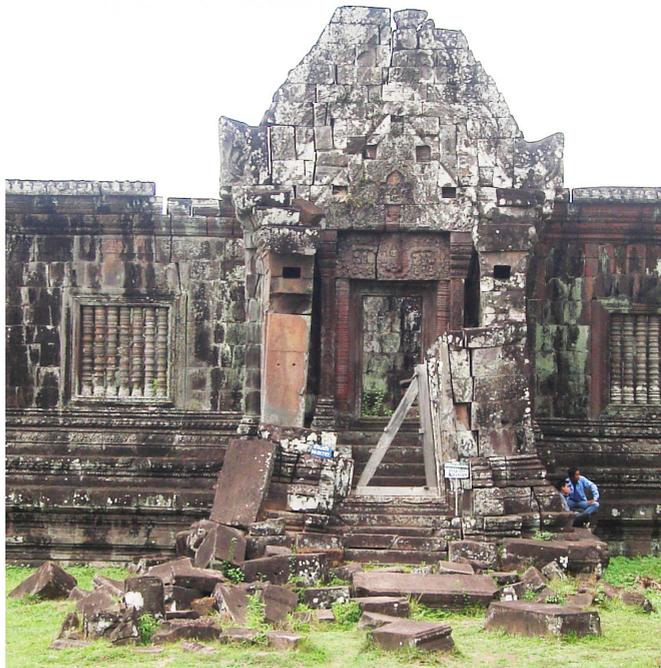
fig.7 : Entrance gate of the southern quadrangle, 2008. Fallen blocks obstruct the gate and the instability of superstructures makes this gallery off limits to the public

The fourth part of the FSP project was to organise a field school to rebuild the south quadrangle entrance porch which was, like the one of the north quadrangle, blocked by stones which fell from above and made dangerous by unstable blocks of stone [fig. 7].

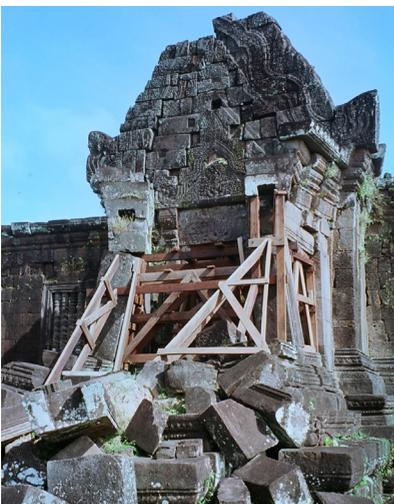
fig. 8 : North quadrangle, 2009. Supporting the entrance gate

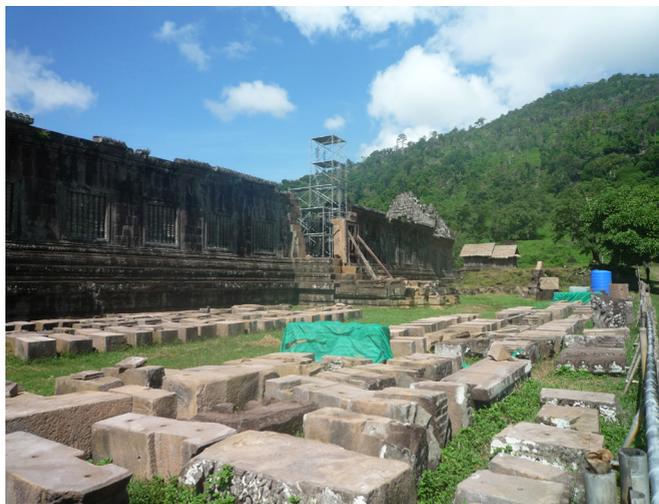
fig. 9 : Sorting, cleaning and restoring of blocks in the southern quadrangle, 2010

Its restoration began in 2008 and took four years. This allowed visitors to finally gain access to the main quadrangle gallery. Rigorous methodology was adopted for these two French and Italian reconstruction projects. The stone-by-stone inventory of monuments, level recordings and deformation analysis preceded the work in order to establish a damage diagnosis and lay out the operations in detail. The Lao personnel, be they architects, archaeologists, engineers, topographers or draftsmen, were involved from the very start which allowed them to gain solid training and a competent team is now in place. After shoring up unstable areas [fig. 8], data selection and recording of scattered stones and blocks taken from dismantled walls [fig. 9], led to assembly on the ground [fig. 10].

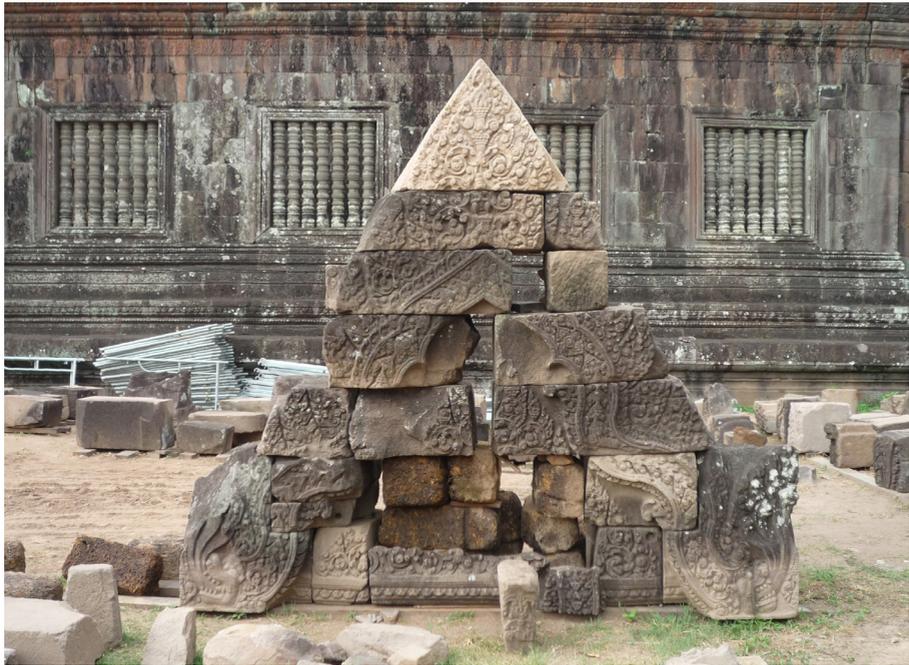
fig. 10 : Southern quadrangle gate, 2010. Sorting and recording recuperated blocks from the ruins for an initial reassembly before rebuilding the pediment. Missing stones will be replaced by new ones

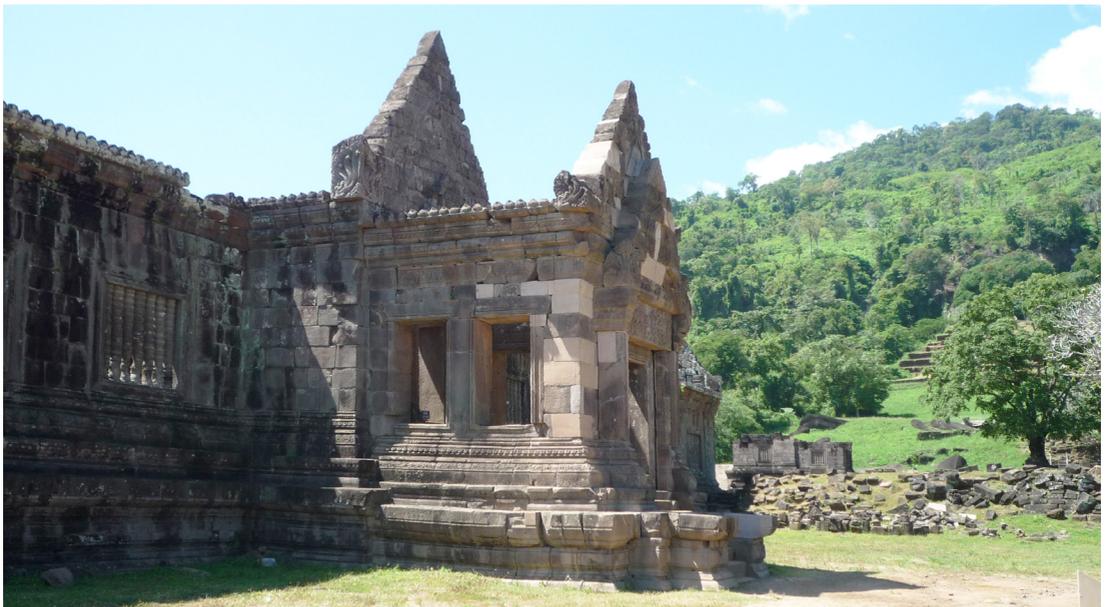
fig. 11 : Southern quadrangle, entrance gate rebuilt with its two pediments (2012)

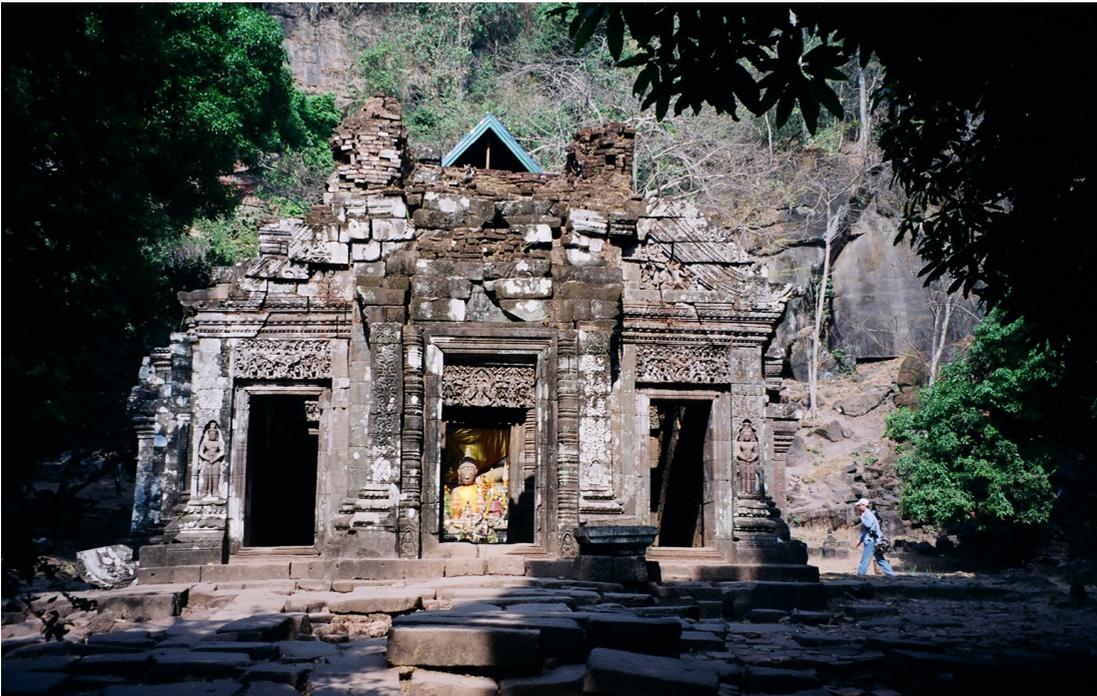
fig. 12 : Eastern side of upper temple, 2008

The upper temple and terrace will be the subject of the last and most delicate worksite. The present state of the building, its original layout and the exceptional quality of its sculpture [fig. 12] require prudent and attentive care. The temple has been disrupted long ago by differential settlements [fig. 13], since it was built on a heterogeneous terrace made by landfill among solid points from the bedrock. The interior of the temple has, for example, subsided 30 cm in relation to the outside walls which has brought about the rupture of numerous blocks. Clearing off the terrace, dismantling the structure and consolidating the foundation will be made all the more complicated since access for materials and machines is difficult.

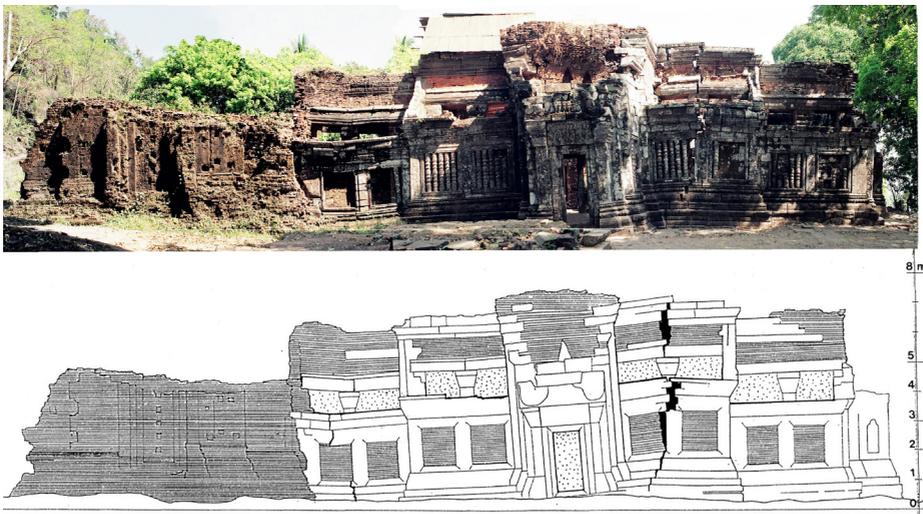
fig. 13 : Southern side of upper temple, present disorganised state due to foundation collapse.
Photographic editing and inventory of deformations

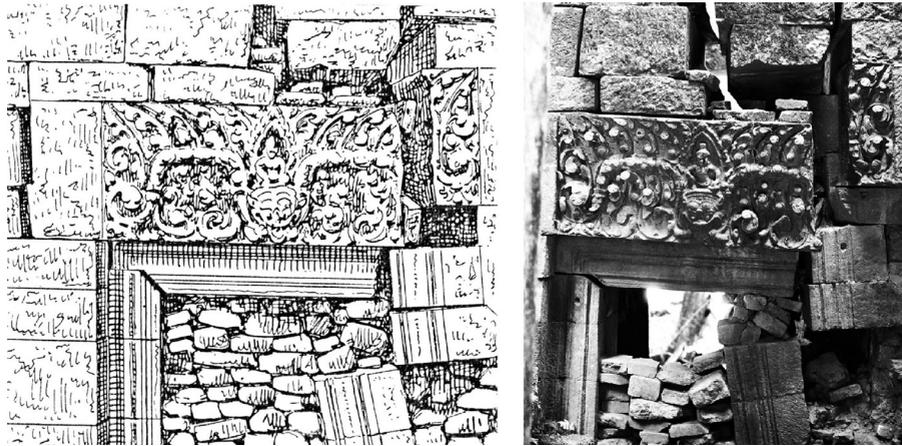
fig. 14 : Upper temple, interior, north-west angle: crumbling of the central portion in relation to the outer walls has led to a crack in the sculpted lintel. To the left, Parmentier's 1912 drawing. On the right, extend of differential settlement in 1997

The old photographs taken by Henri Parmentier in 1912 show that the monument has changed little in one century, with a few exceptions: disturbances in the upper temple have worsened [fig. 14] and the collapse of part of the lateral wall and its window have further destabilised the northern quadrangle porch. Trees which grew at that time on the walls and through the flagstones have since disappeared. On the other hand, frangipanis on either side of the stairs and ramps had not yet been planted [fig. 15]. Today they are part of the charm of the site (fig. 3) and losing them would be a shame, but they must be cut down for the stairs to be restored. They are also beginning to endanger the structure: one of them was blown down by typhoon Ketsana in September 2009, causing several stones from the 4th terrace to fall.

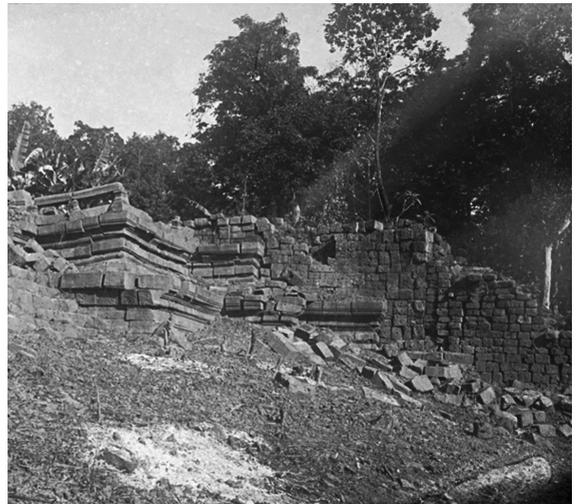
fig. 15 : Fourth terrace access in 1912 as seen from the south. The original stairs were covered with recuperated stone on which we can see that the present-day frangipanes had not yet been planted (Photo EFEO-Parmentier PARH00401)

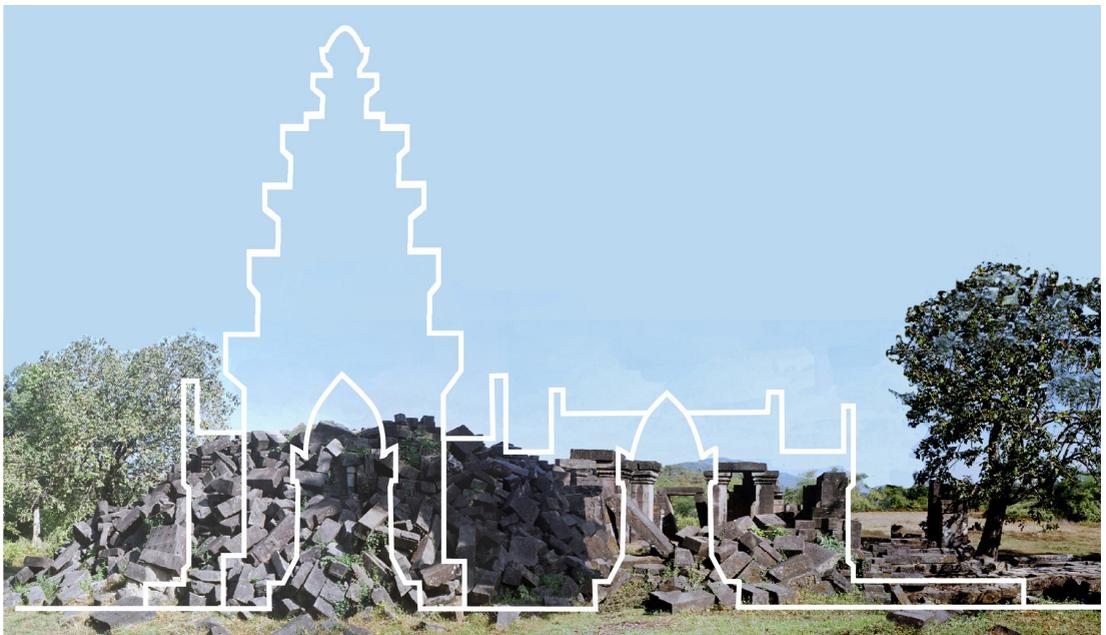
fig. 17 : Hong Nang Sida temple, south side and supposed contour of projected, although never finished, monument

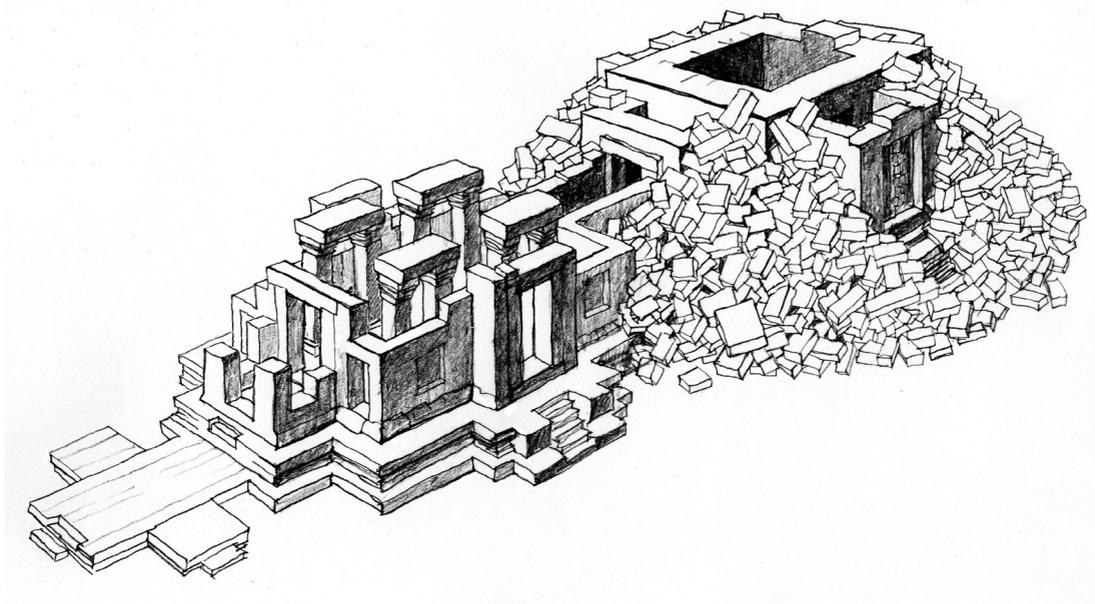
fig. 18 : Proposition for the presentation of Hong Nang Sida temple

Currently being studied by a Korean team, the anastylosis of this tower will prove to be very difficult since its stones, most of which are not sculpted, are cuboid and practically impossible to identify and reassemble. Even if we were able to rebuild it, the result would be of little interest since it would only be a brut mass of rough-hewn stones, flanked by an uncovered *avant-corps* and *mandapa*. In its present state, on the other hand, the tower is impressive by the size of its ruin, by the sight of its heavy sandstone blocks thrown pell-mell yet now stable; they can fall no further. While so many temples, be they vast or modest, have been progressively restored all throughout the ancient Angkorian Empire, we feel that some can remain as they stand to bear witness to the process of destruction. Hong Nang Sida would be a superb example of this after a bit of work to improve its presentation: straightening the *mandapa* walls and gate, and above all taking out the stones which fell inside the tower, the *avant-corps* and the *antarāla*, which would grant access to the interior of the monument [fig. 18].
